Posting Type	Advisory
Date Submitted	2024-04-23
Subject	Invalid EC due to unresolved laser correction, often as a result of sampler contamination
Project	CSN
Sites	All possible
Sample Period	2007 - present
Parameters	Raw and blank corrected elemental carbon (EC) and pyrolyzed carbon (OP) by reflectance and transmittance (88321, 88380, 88381, 88357, 88328, 88378, 88379, 88388)
Recommendation	Use EC data prior to January 2024 with caution and consider applying OP test.
Submitter	Sean Raffuse and Alex Murrain, sraffuse@ucdavis.edu

Executive Summary

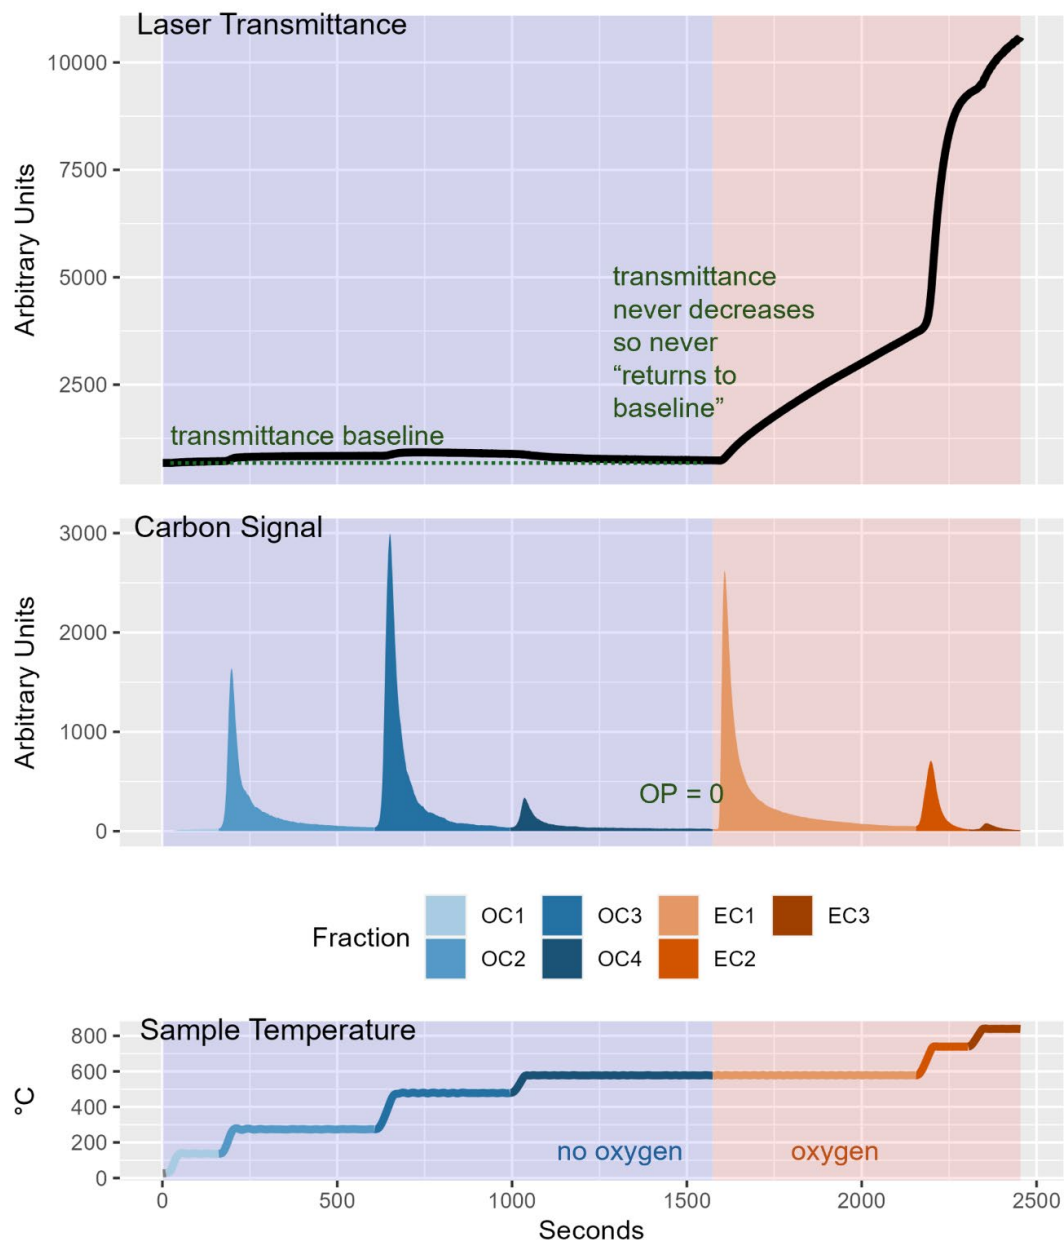
Figure 2 shows an example of a laser correction failure. In this case, the initial transmittance is very low (i.e., the sample is very dark). Charring may be occurring during the no-oxygen phase, but it does not reduce the already low transmittance. Because of this, there is no way to estimate the amount of charring on the sample. The OP fraction is zero and no correction is applied to the total OC or EC.

Figure 2. A thermogram for TOA analysis of a CSN filter with no laser correction.

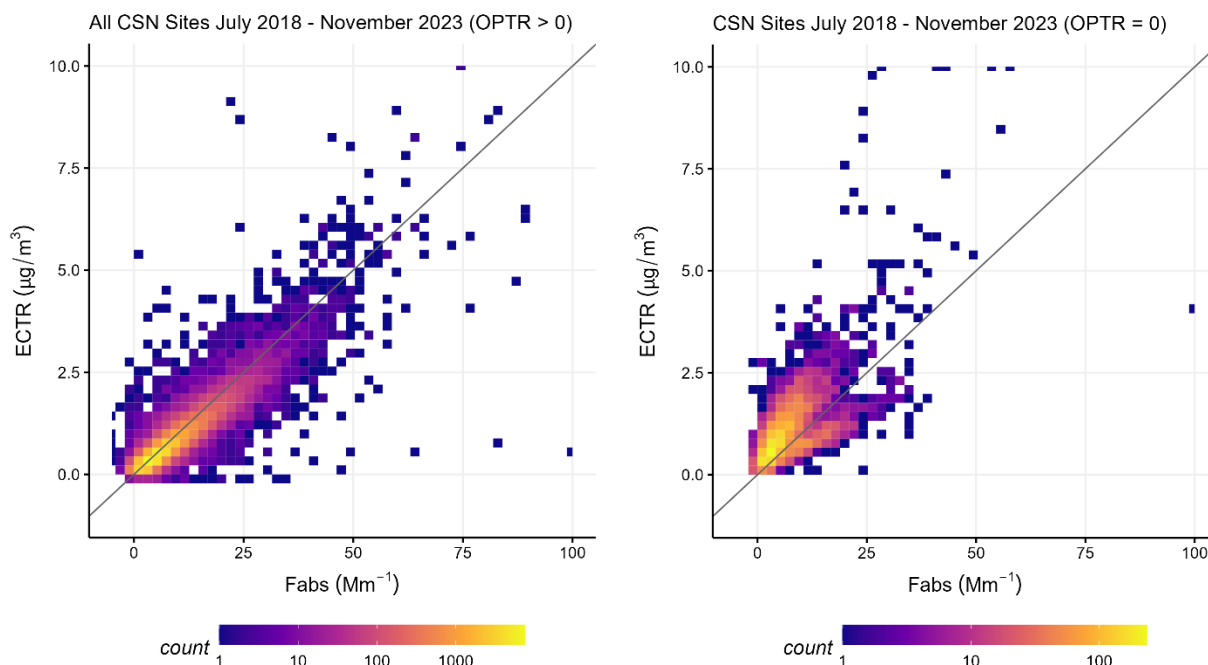
Figure 3. Relationship between ECTR and Fabs in CSN when TOA laser correction is successful (left) or unsuccessful (right). Brighter yellow colors indicate more samples within the square. Note the logarithmic color scale.

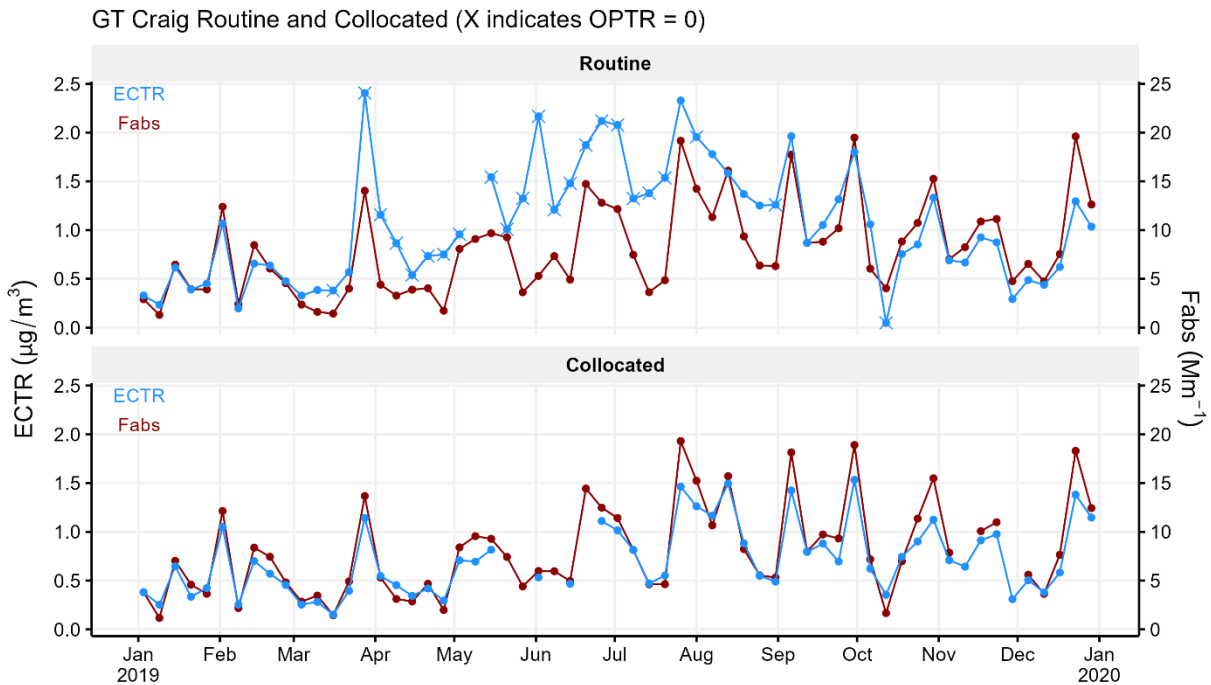
sampling event, it suggests an issue with one or both measurements. This can be seen by looking at the measurements together in a time series. Figure 4 shows one year of Fabs and ECTR concentrations at the G.T. Craig, Ohio site (39-035-0060). G.T. Craig has both a routine and collocated monitoring setup. During the first two months of 2019, Fabs and ECTR were well correlated for both routine and collocated samples. Between March and August, the relationship at the routine site was degraded, with ECTR much higher than expected for the measured Fabs. Because the ECTR continues to agree with Fabs at the collocated site during this time period, and Fabs is very similar between collocated and routine, the routine ECTR measurement is most likely in error. All TOA measurements where the raw OPTR was zero (i.e., no laser correction) are denoted in the figure with blue X's. Nearly all the routine samples in the period with poor agreement have no laser correction. The ECTR error on these days is significant, with some days high by over 200%.

Figure 4. Time series of ECTR and Fabs at G.T. Craig routine and collocated sites for 2019.

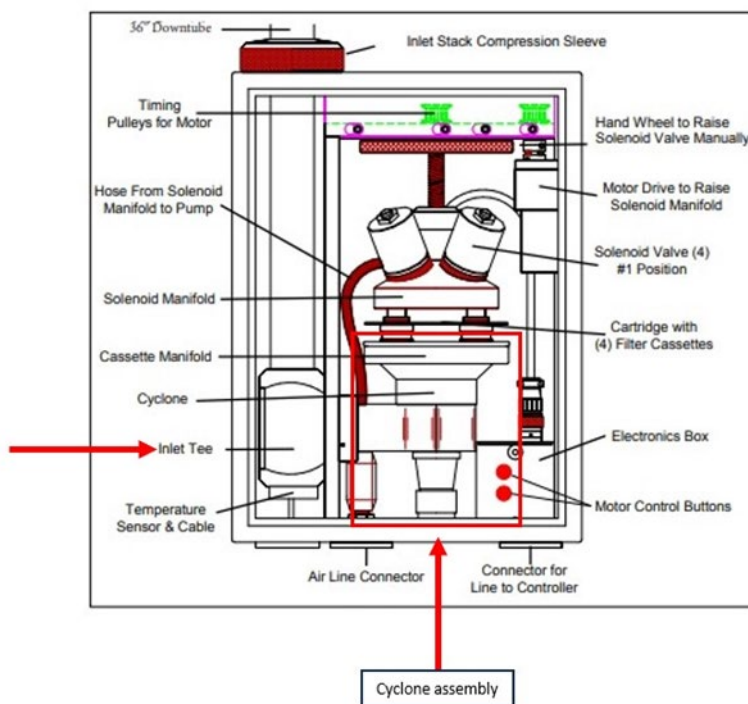
Figure 5 shows a schematic of the URG 3000N sampler. At one site with recurrent zero OP values, the sampler head was found to have a loose seal with the downtube, which led to rotation while the pump was on. Grease had been used and the o-ring no longer produced a tight seal. Black dust was found in the URG inlet tee and around the cyclone. The quantity of black dust was large enough, it was depositing on the quartz filters during sampling. Figure 6 shows an example of the buildup of black dust.

Figure 5. Schematic of URG 3000N sampler body with inlet tee and cyclone assembly highlighted with red arrow. Excerpted from the URG3000N Operations Manual.

Although the chemical composition and exact origin of the black dust has not been determined, the issue can be resolved with sampler maintenance. It is recommended that URG 3000N samplers should be inspected and cleaned on an annual basis, specifically the inlet cap, downtube, inlet tee and cyclone assembly.

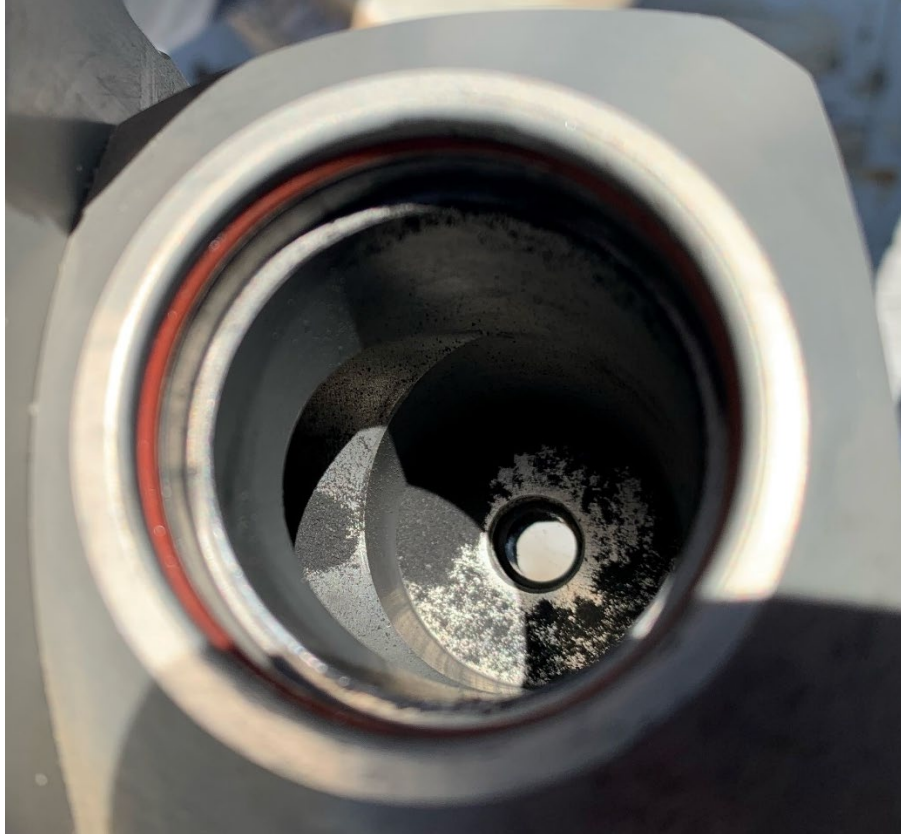
The analytical cause of the incorrect EC measurement is related to a saturated laser response. This occurs when there is a very dark deposit on the quartz filter. The dark deposit can come from ambient sampling or a sampler malfunction. Based on the pattern of occurrence and reporting from the field, we conclude that many of the cases in CSN are due to sampler malfunction.

Beginning in 2022, sites began reporting a “black dust” on their quartz filters and in their URG 3000N samplers used to collect quartz samples for TOA. Some sites also reported URG sampler heads rotating during sampling. EC measured from these samples were elevated compared with the Fabs measured from the PTFE samples. The LJ qualifier code was applied to most EC measurements and sites asked questions about the increase in frequency of these qualifier codes.

Figure 6. Photo of URG 3000N Inlet Tee with “black dust” buildup (taken July 13, 2023).

1. Remove cap from downtube, downtube from inlet tee, and inlet tee from frame.
2. Rinse with water, wipe, and blow dry. Do not use WD-40 or other non-water solutions.
3. Reassemble and reattach cyclone, inlet tee, downtube, and inlet cap. Inlet cap should fit tight around the top of the downtube. If fit is not tight (i.e., cap is easily removed from, or rotates around, downtube with light force), replace the o-ring and/or downtube. Figure 7 shows the o-ring of the inlet cap.

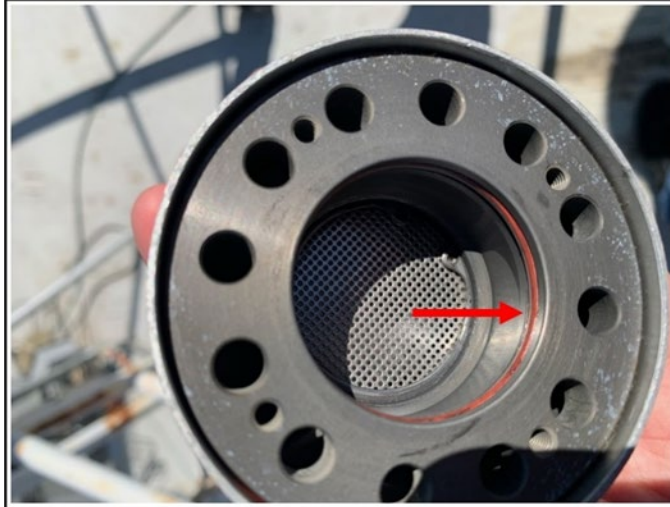
Figure 7. Photo of Inlet Cap removed from Downtube with o-ring indicated by red arrow (taken July 13, 2023).
