Site Sampling Technical Memorandum, Lower Otter Creek and Confluence, Maumee Area of Concern, Toledo, Ohio

Task Order No. 0027, Contract No. EP-R5-11-09

PREPARED BY: CH2M HILL

DATE: January 18, 2017

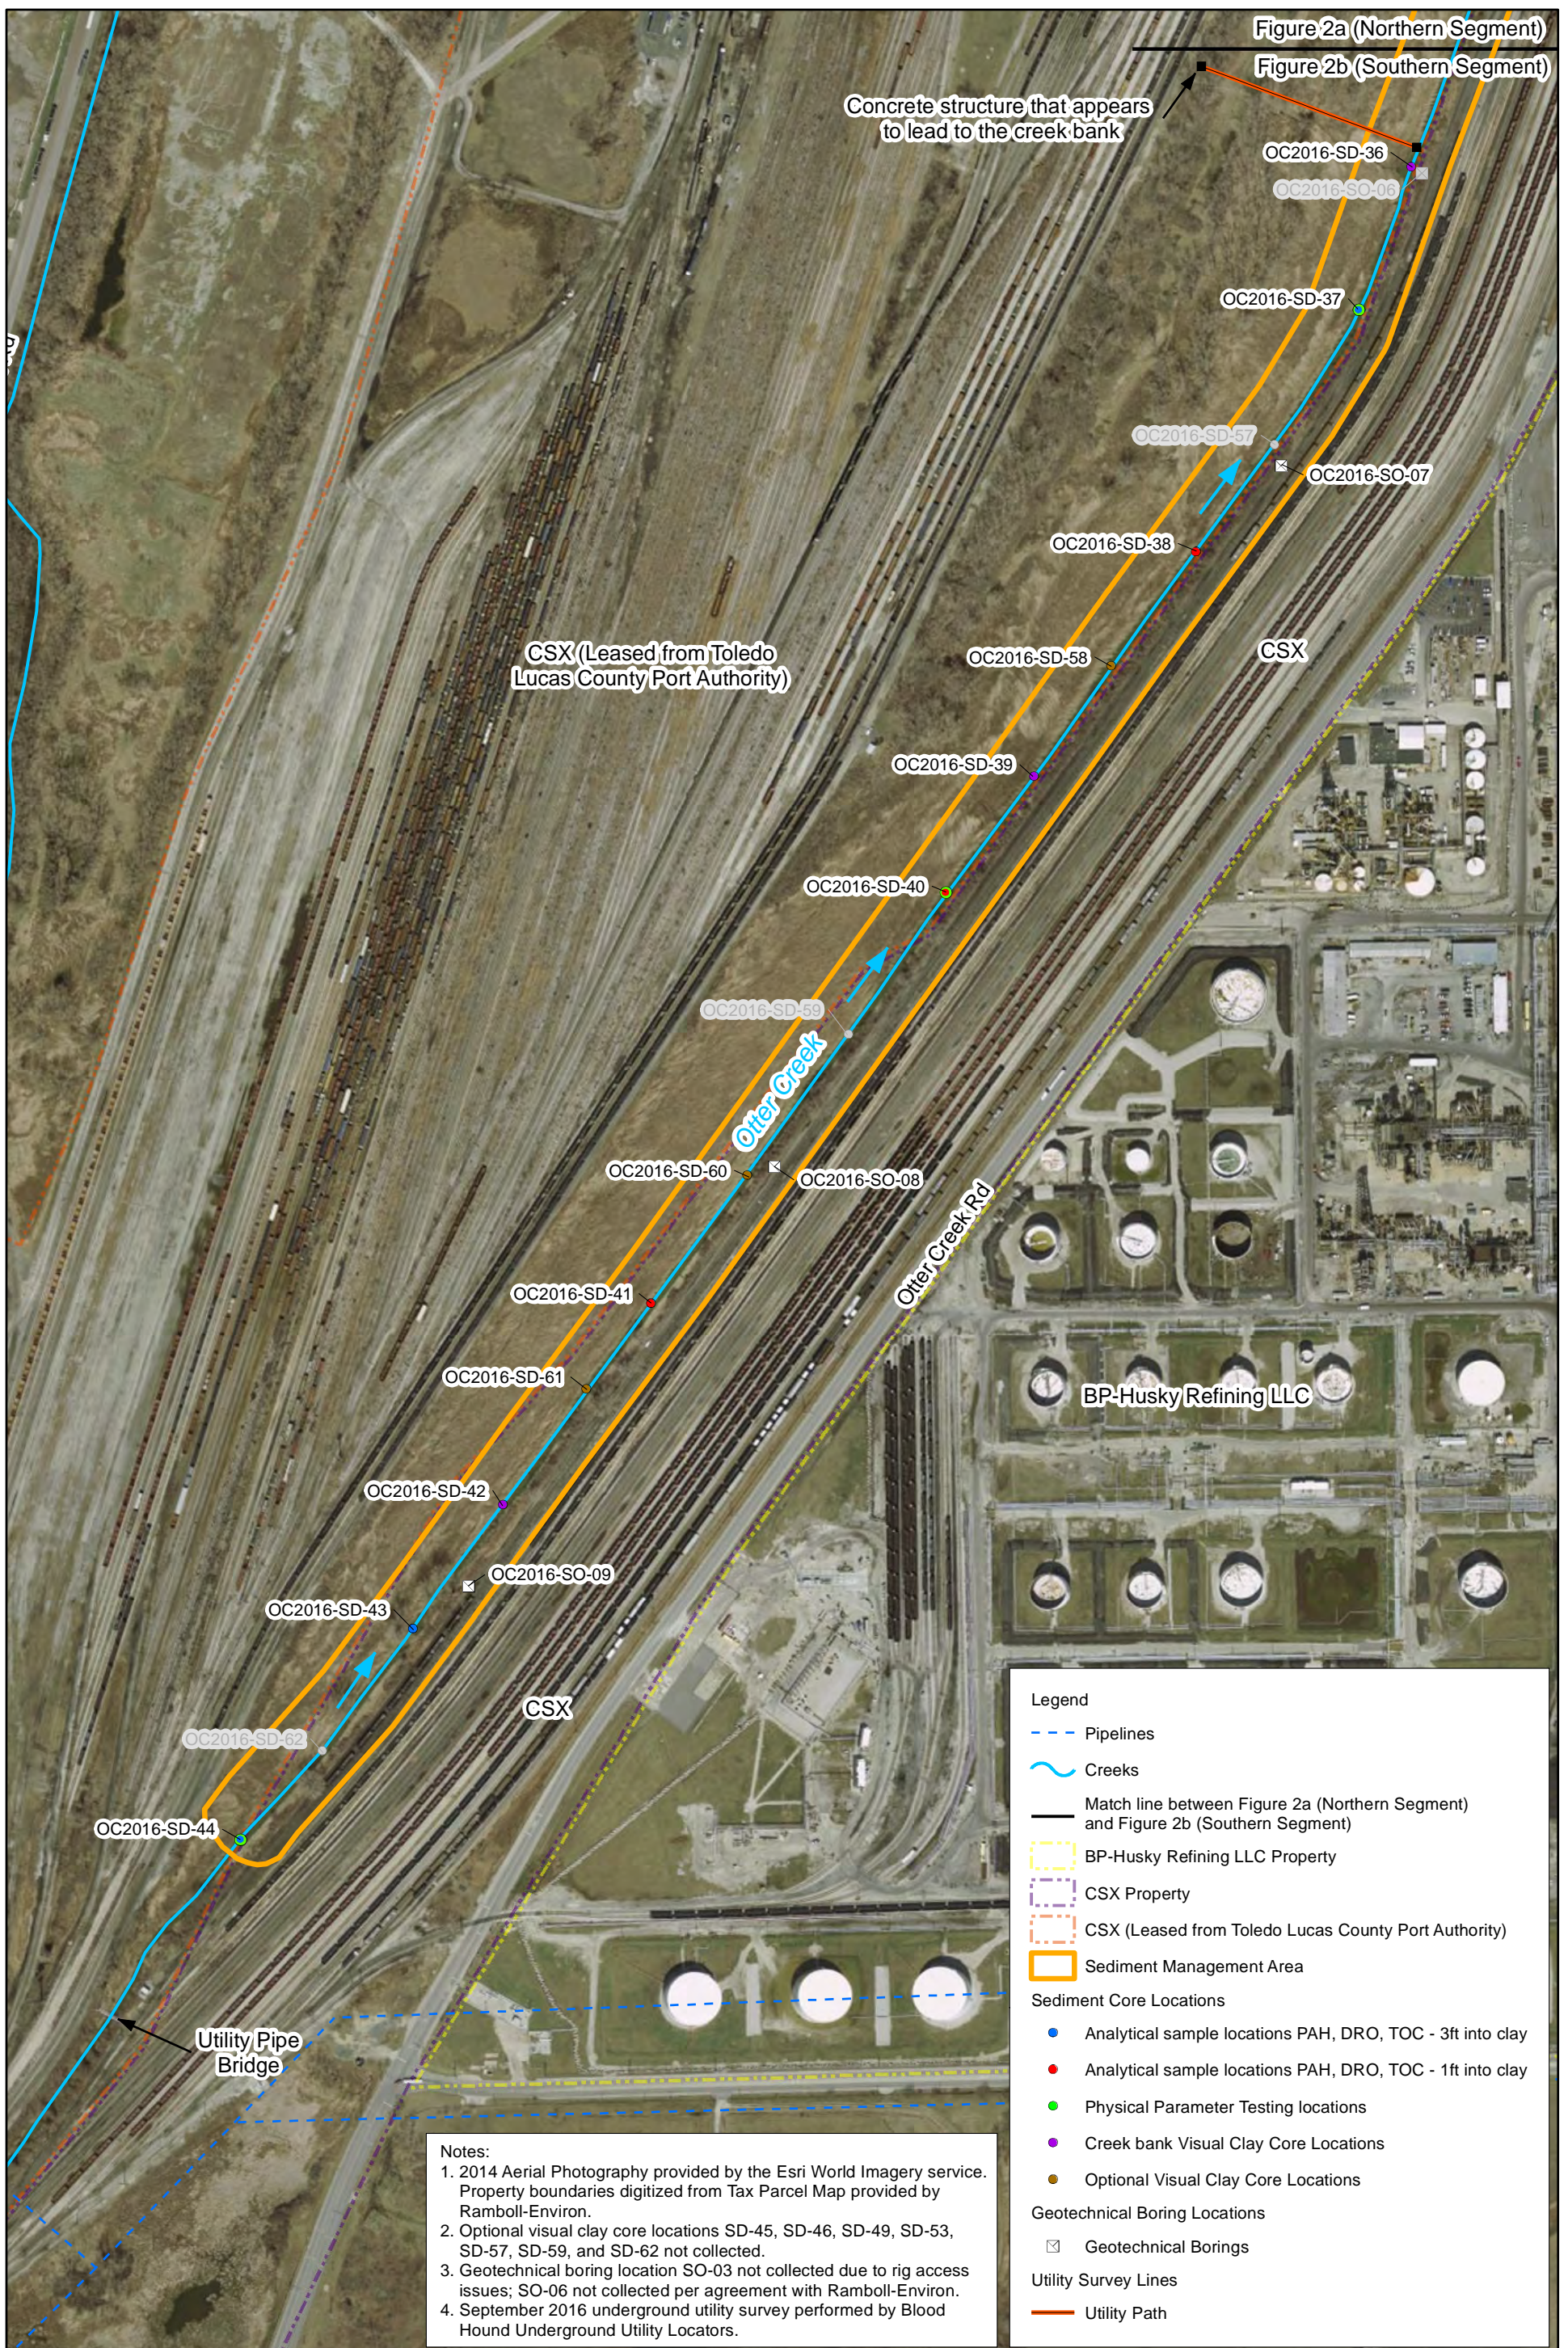
Figure 2b
 Sample Locations, Utilities, and Site Features - Otter Creek (Southern Segment)
 Pre-Design Investigation, September 2016
 Otter Creek and Confluence Area, Toledo, Ohio

Concrete structure that appears to lead to the creek bank

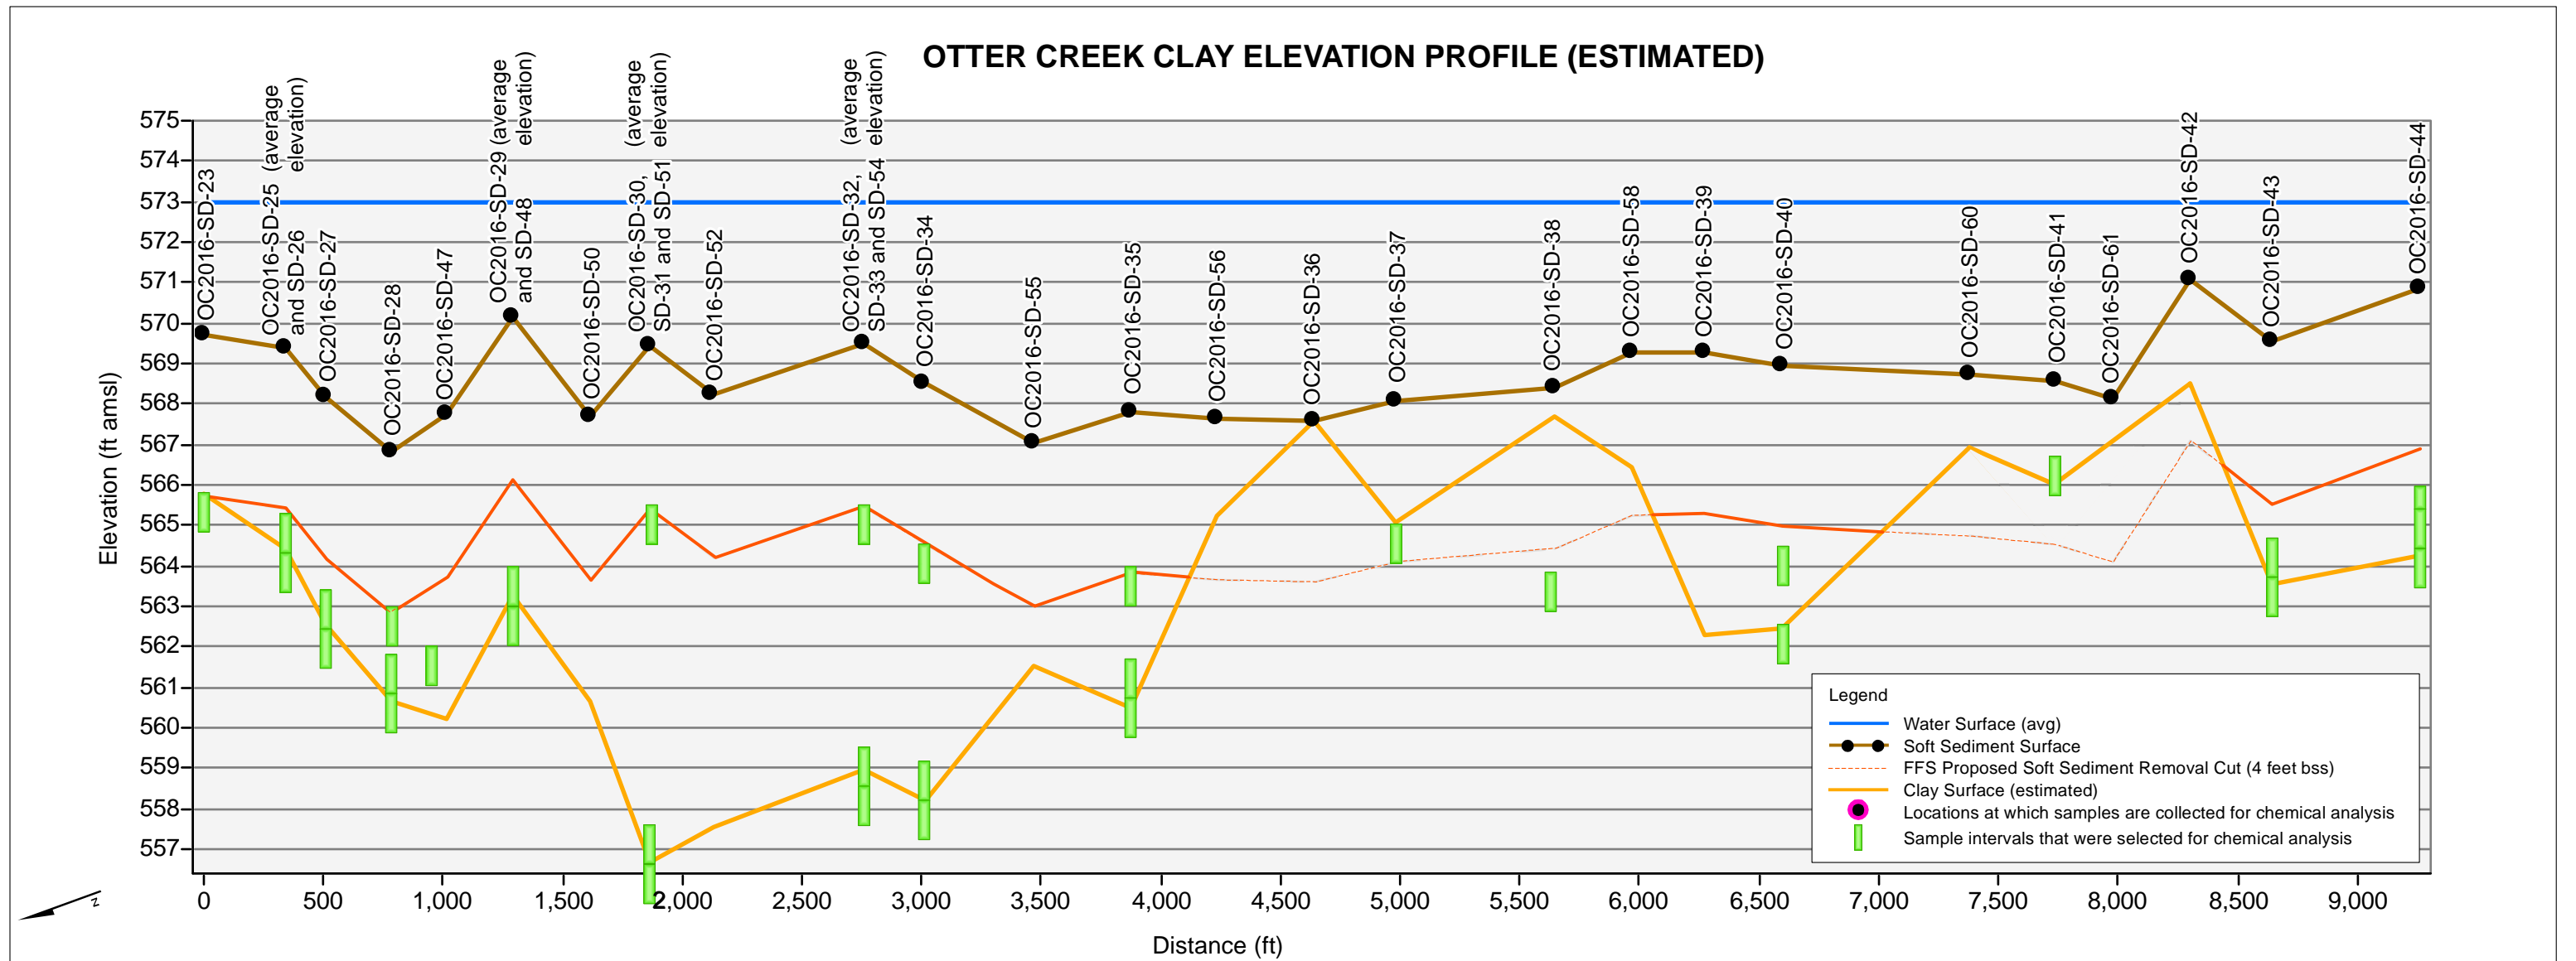
Figure 4a
 Otter Creek Profile
 Pre-Design Investigation, September 2016
 Otter Creek and Confluence Area, Toledo, Ohio

Thirty-three cores were advanced into the native clay to vertically delineate the thickness of soft sediment and identify the surface of the native clay in Otter Creek. The average depth to native clay in the creek was 6.3 feet bss, with an average clay surface elevation of 562.58 feet amsl. The shallowest elevation of the native clay (at approximately 568 feet amsl at 2.6 feet bss) was observed at the southern portion of the project area near sample location (SD-42). The deepest elevation of the native clay (at approximately 555 feet amsl at 13.9 feet bss) in the creek was observed at location SD-31 in the northern segment north of the CSX road bridge. Figure 4A presents the native clay elevations in Otter Creek and the FFS (Ramboll 2013) proposed dredge cut line of 4 feet bss.

Note:
 1. 2014 Aerial Photography provided by the Esri World Imagery service.
 2. At transects with more than 1 sample location, the sediment and clay elevations are averaged to a single elevation representing that transect.

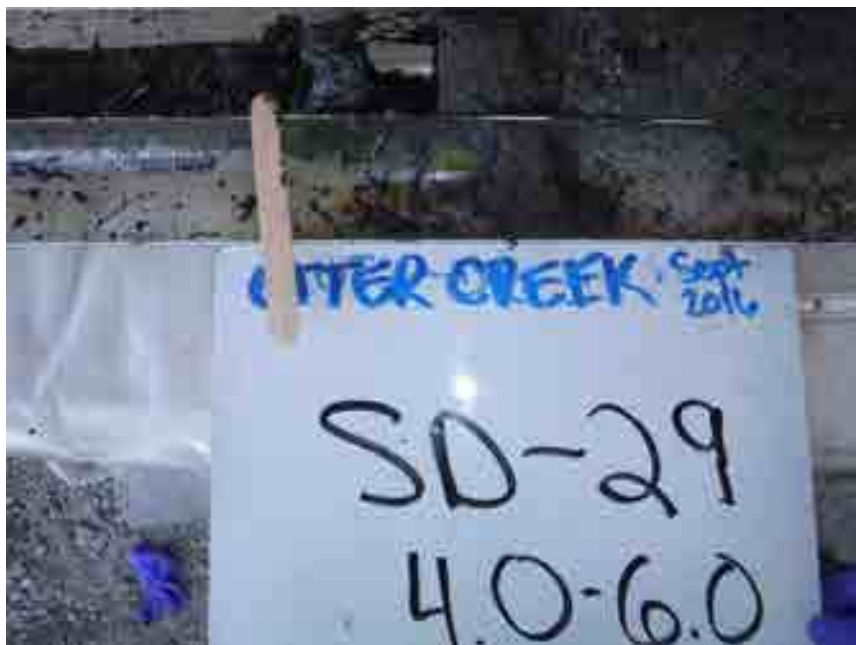
SD-29, 4.0-6.0 staining.
