CONTINUOUS PM_{2.5}

Road to Transition

South Coast AQMD

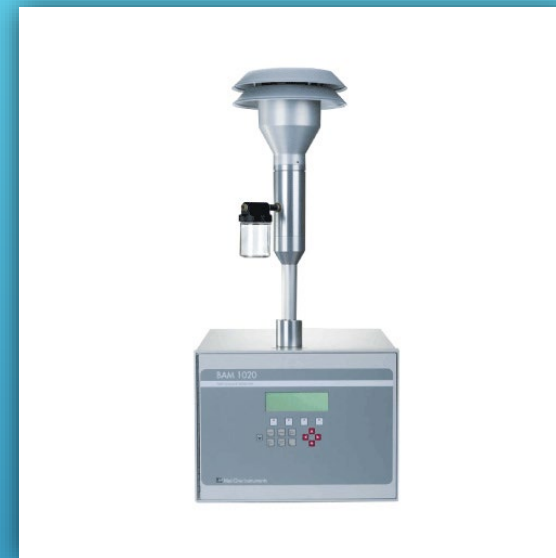
- ▶ Working with Met One on Third Generation 1020 FEM (eight)
 - ▶ All eight passed zero test in shop, failed in field
 - ▶ Installation procedures may have contributed to initial failures in field
 - ▶ Required disassembly and cleaning to pass zero test. Out of four deployed one may need to be sent back to factory
 - ▶ Would not pass zero test using ambient air, only station air

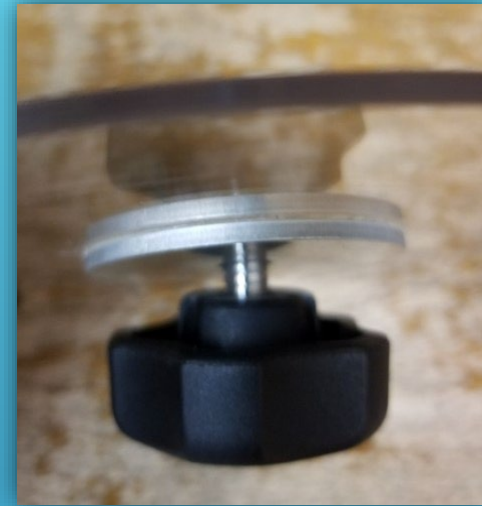
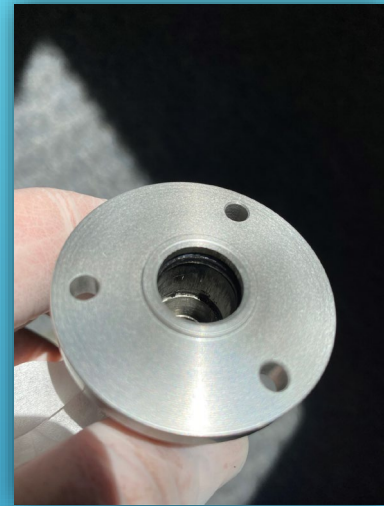
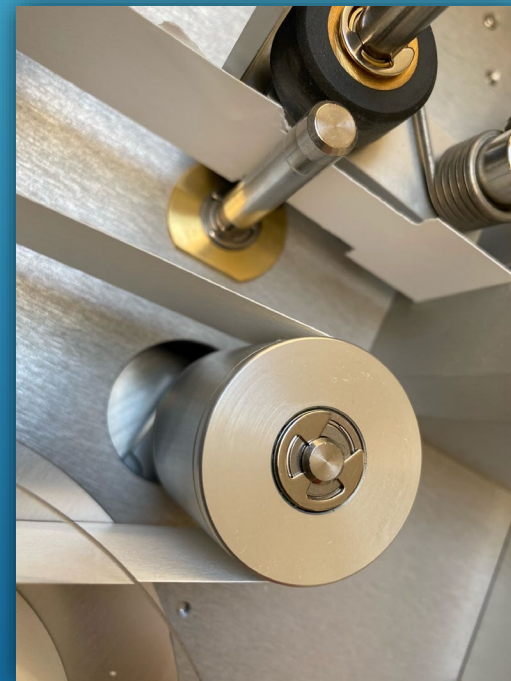
- ▶ Dirty nozzles due to improperly assembled take up reel assembly leading to tape misalignment
- ▶ Zero test affected by a high background value when received from factory
- ▶ New pinch rollers build up tape debris quickly and must be cleaned frequently
- ▶ Deformed washer on nozzle assembly
- ▶ Communication issues required work-arounds to function properly

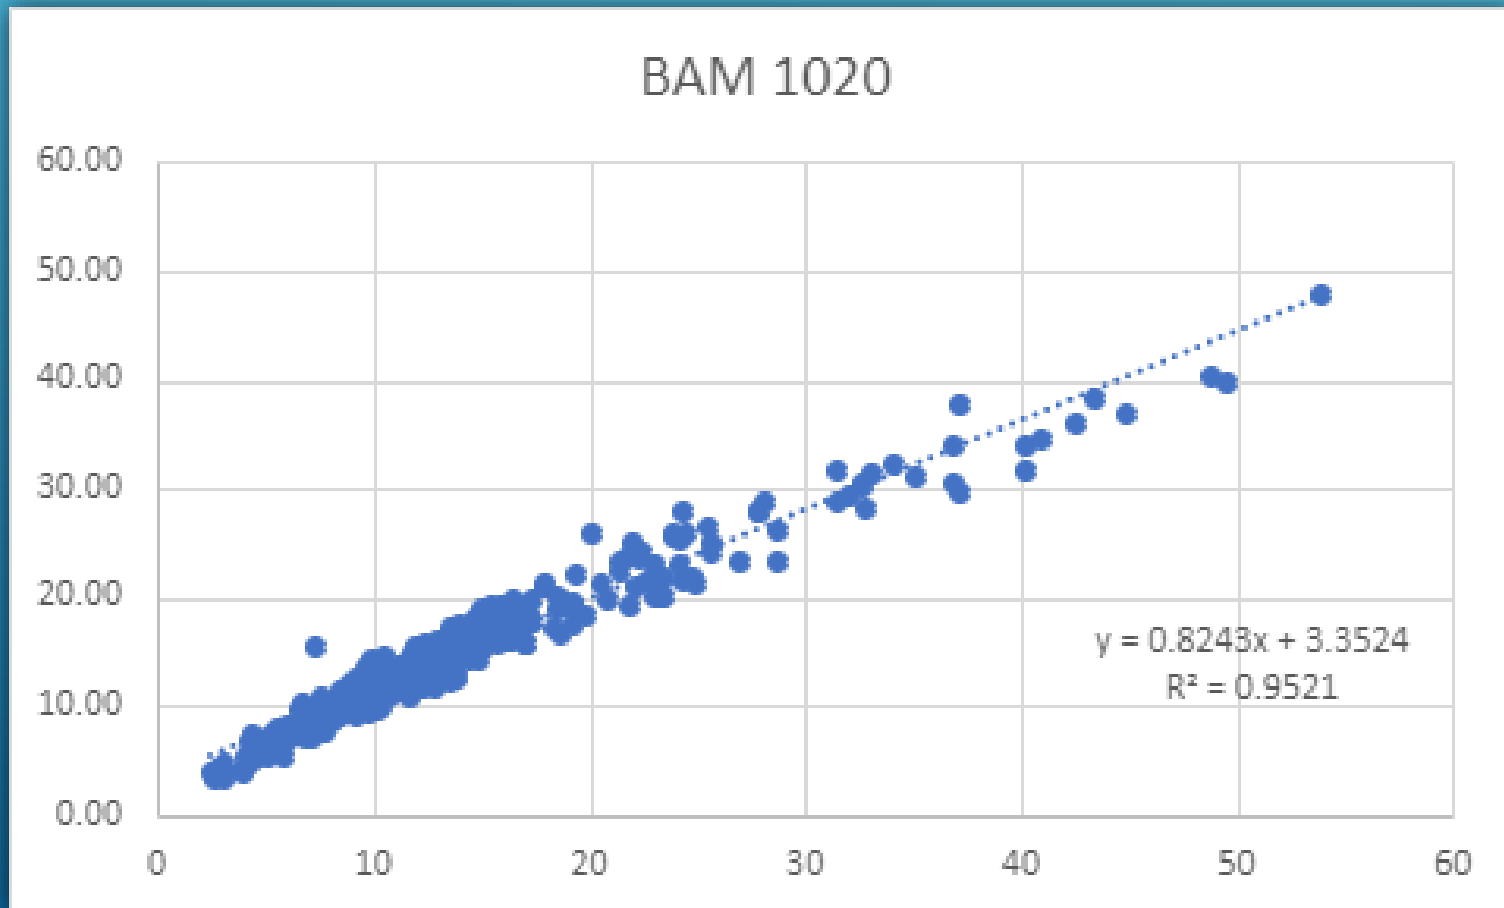
Compton, CA Annual 2022 FRM DV Site, One year of 1020 Second Generation Data Available

- ▶ Slope Criteria 1.0 ± 0.1 - **FAIL**
- ▶ Intercept Criteria ± 2.0 - **FAIL**
- ▶ R^2 Criteria > 0.81 - PASS

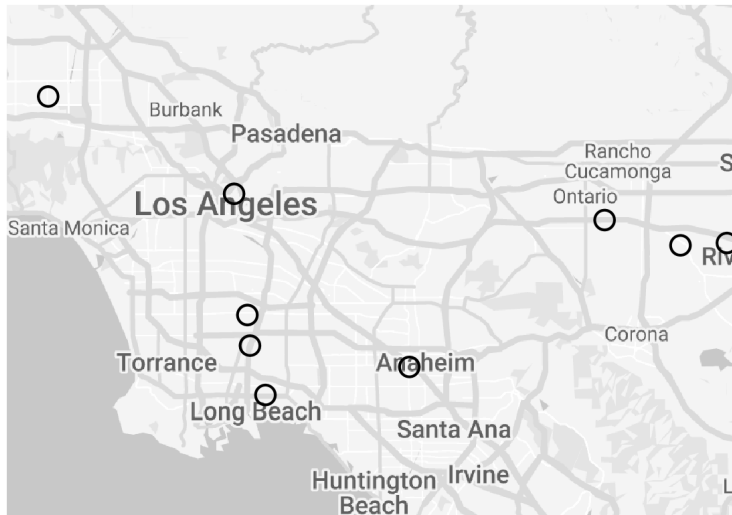
- ▶ Data from collocated FRM/FEM locations from 2015-2021
- ▶ Design Values were compared to NAAQS daily and annual standards as the primary monitor
- ▶ PM2.5 design values (DV) are calculated by the following method:

FRM Design Value	FEM Design Value
Standard EPA Method	Missing FRM Data is replaced with FEM Data	FEM Data Only

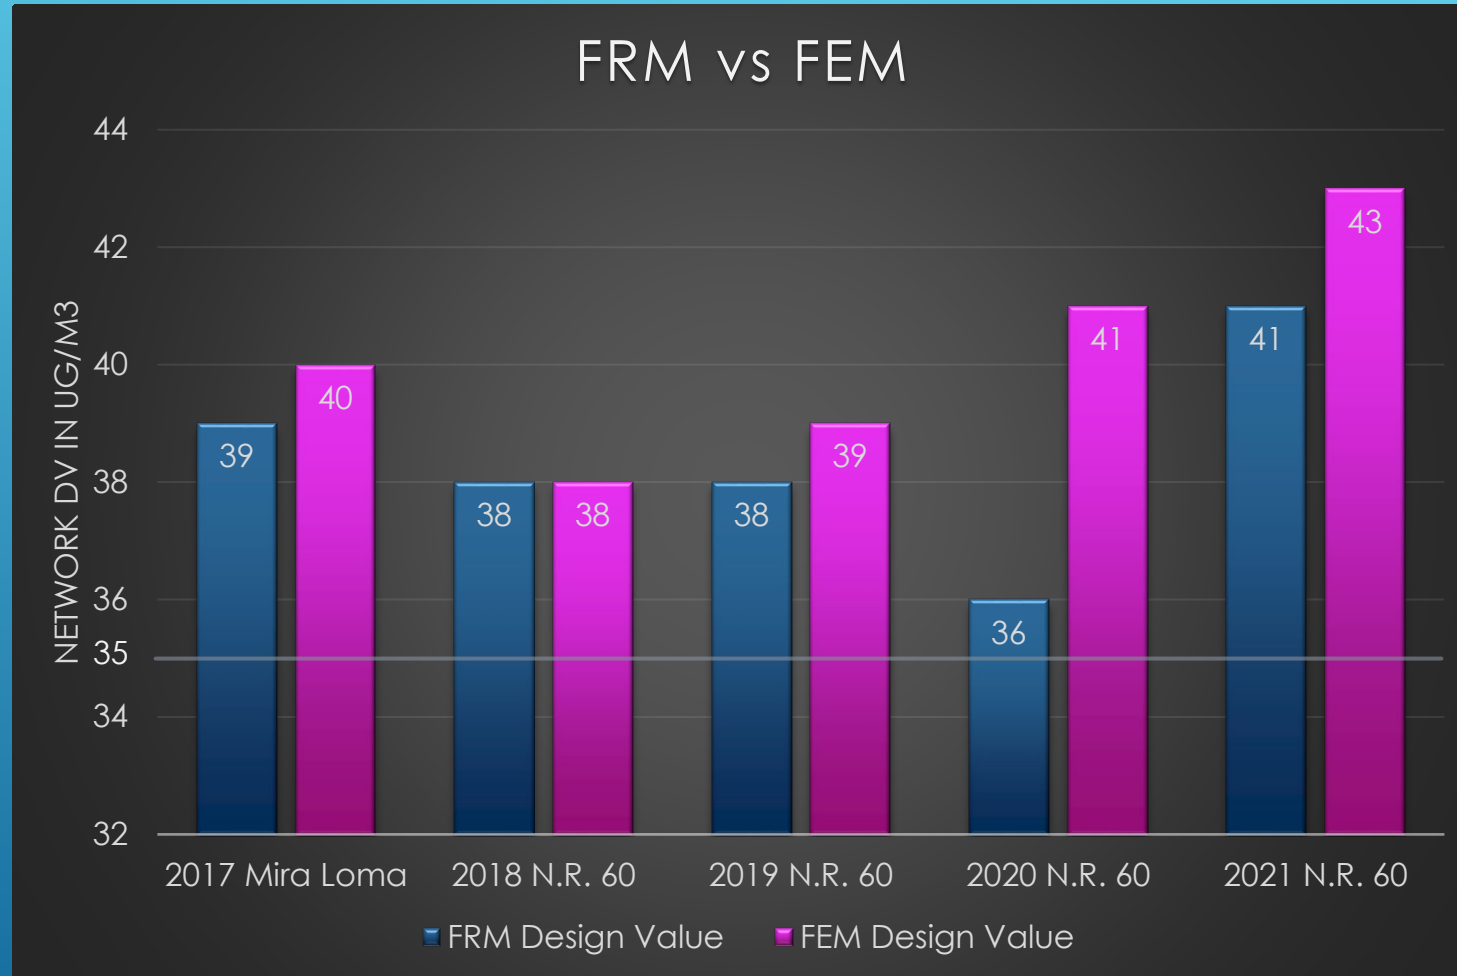
PM2.5 DAILY DESIGN VALUE COMPARISONS

- ▶ If FEM is the primary monitor, the design value can increase up to 5 $\mu\text{g}/\text{m}^3$ at a site
- ▶ Equals up to 14% of Daily NAAQS standard

- ▶ In certain instances, 24 hour design values can be as much as 1- 5 ug/m³ higher utilizing FEM as the primary monitor
- ▶ In certain instances, annual design values can be as much as 2.3 – 2.9 ug/m³ higher utilizing FEM as the primary monitor
 - ▶ This can be the difference between attaining the 15 ug/ug secondary standard
- ▶ Moving to a FEM network, discontinue FRMs?
 - ▶ How will we know results of Comparability Assessment if we discontinue FRM?
 - ▶ We have found the Comparability Assessment can fail the following year
 - ▶ Maintaining FRM and FEM networks are twice as much work while EPA funding is decreasing
- NAAQS Refinement
 - Consider utilizing FRMs to develop a location specific adjustment
 - Develop PM_{2.5} FEM specific NAAQS
