Stainless Steel Contamination on CSN Filters?

Sean Raffuse, Warren White, Nicole Hyslop, Alex Murrain
UC Davis – Air Quality Research Center

CSN chromium (Cr) and nickel (Ni) data are intermittently contaminated. Use with caution.

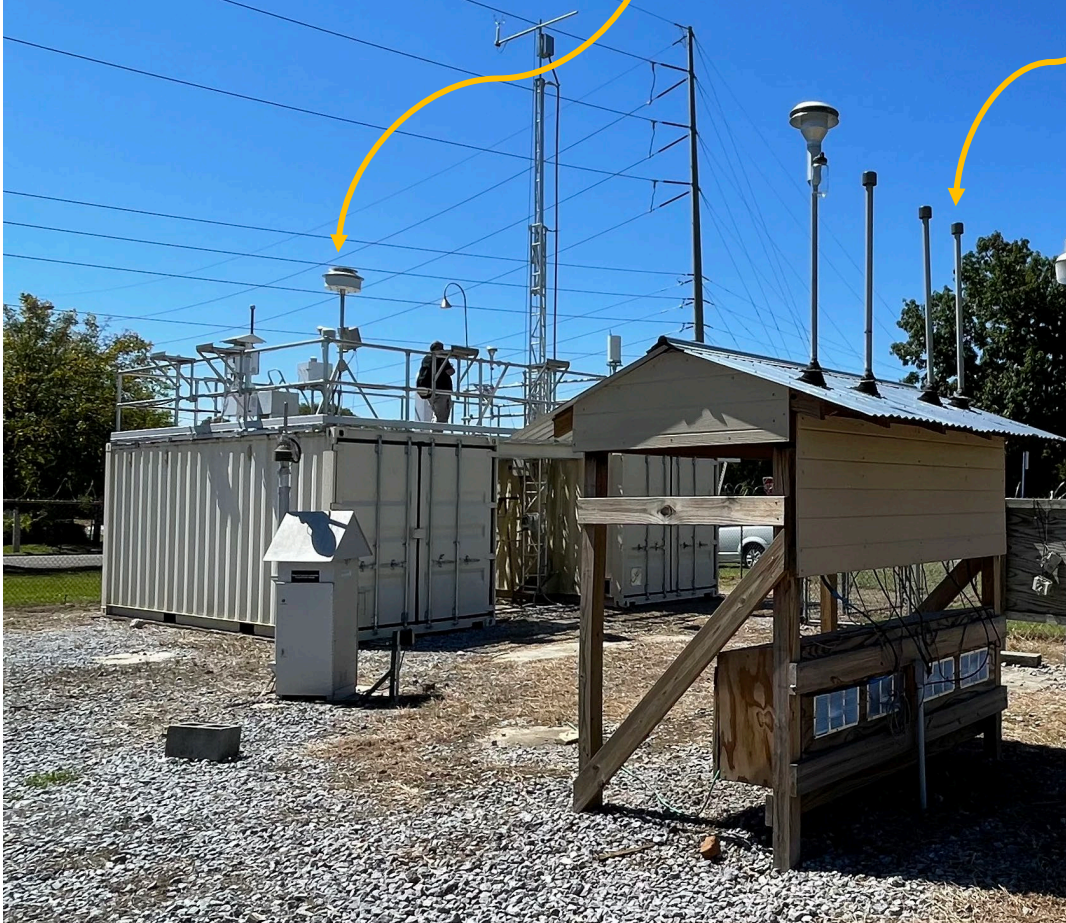
Collocated CSN and IMPROVE

Gorham et al., 2021

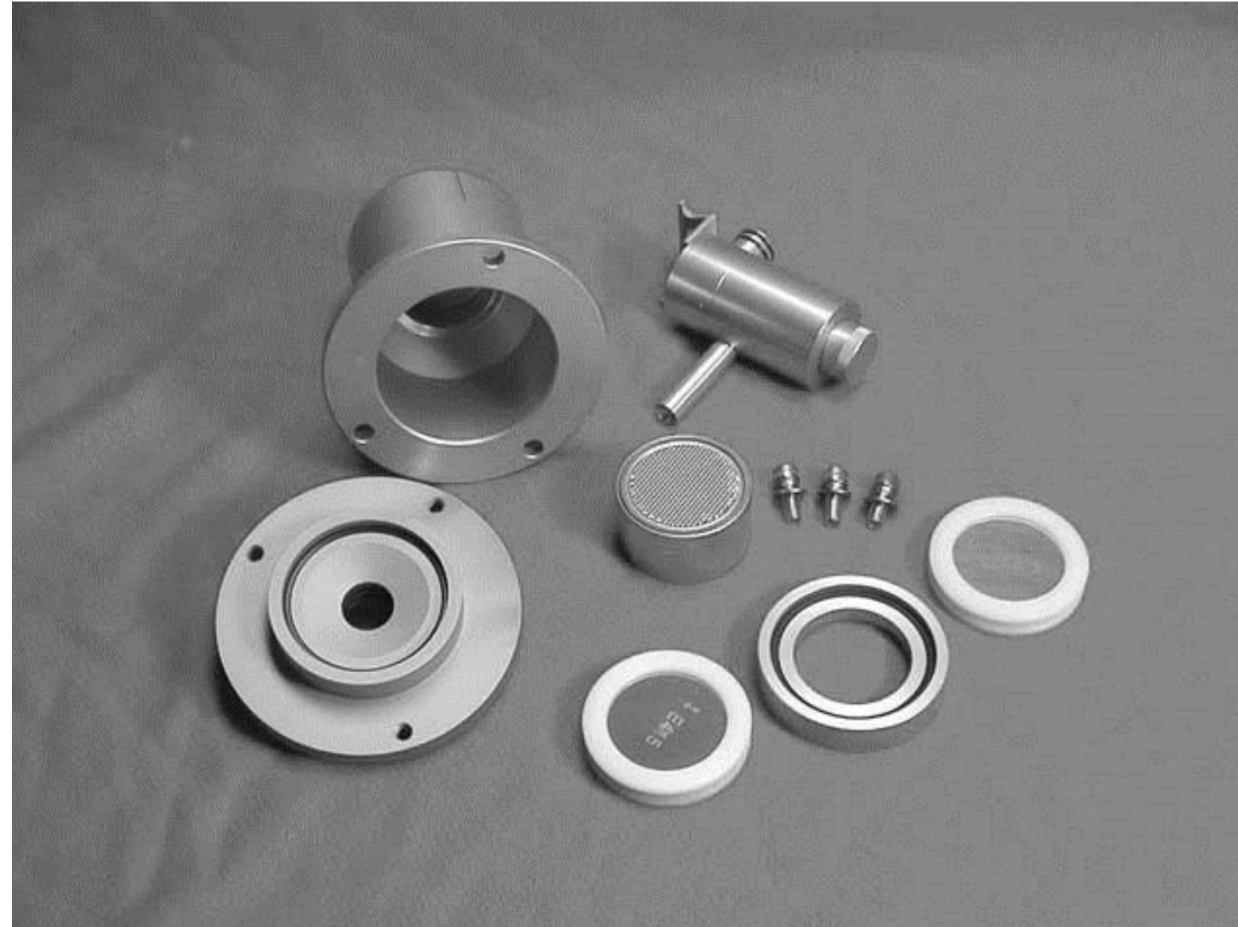
Disassembled SASS canister (from Met One SASS Field Operation Manual)

Is it the sampler?

Screens?
Screws?
Canister body?

Analysis of sampler components has been inconclusive, but circumstantial evidence implicates the screws
