Posting Type	Advisory
Date Submitted	2024-04-23
Subject	Invalid EC due to unresolved laser correction, often as a result of sampler contamination
Project	CSN
Sites	All possible
Sample Period	2007 - present
Parameters	Raw and blank corrected elemental carbon (EC) and pyrolyzed carbon (OP) by reflectance and transmittance (88321, 88380, 88381, 88357, 88328, 88378, 88379, 88388)
Recommendation	Use EC data prior to January 2024 with caution and consider applying OP test.
Submitter	Sean Raffuse and Alex Murrain, sraffuse@ucdavis.edu

Executive Summary

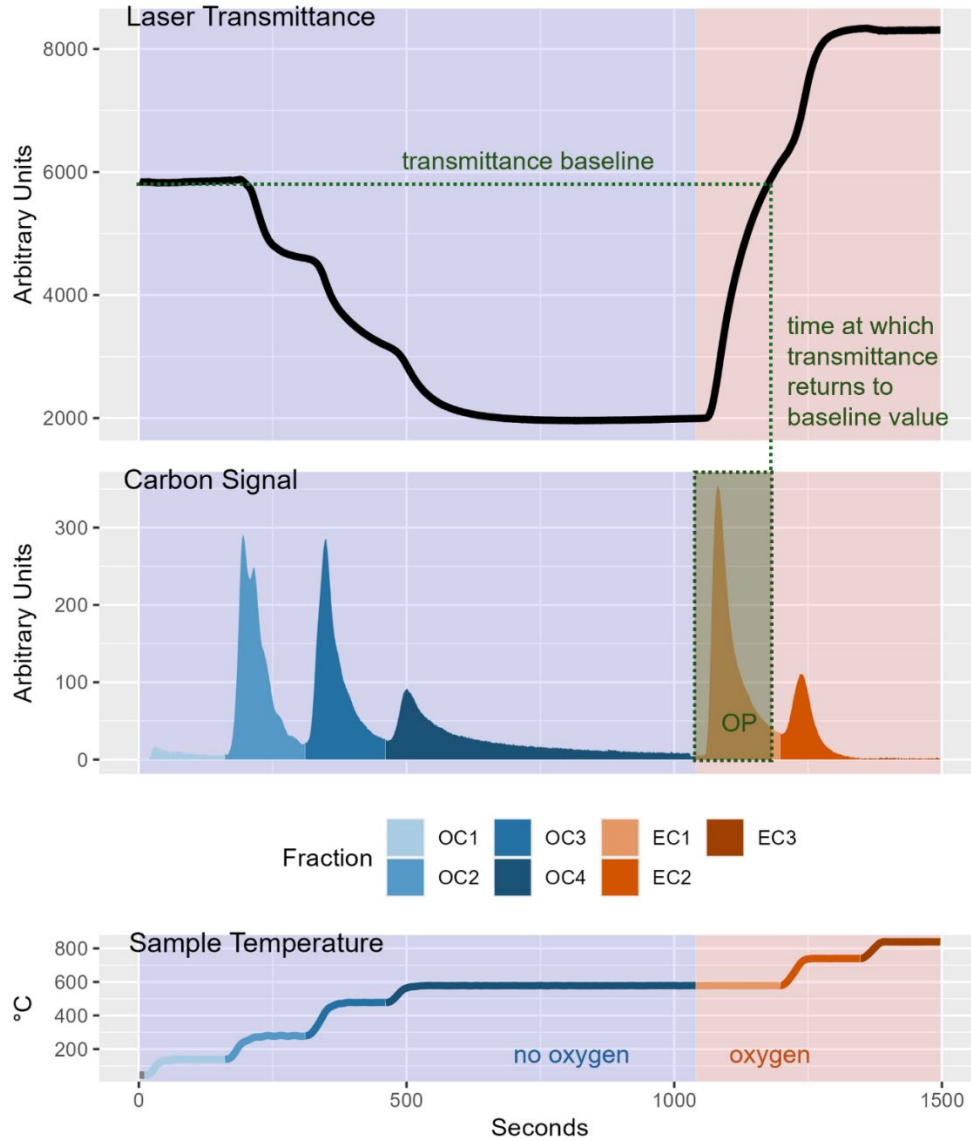
The organic carbon fractions (OC1, OC2, OC3, and OC4) are analyzed by heating the sample with no oxygen at successively higher temperatures (Figure 1, bottom panel, blue region) following the IMPROVE_A protocol. The evolved carbon is converted to methane and measured (Figure 2, middle panel). Then, oxygen is added and the elemental carbon fractions (EC1, EC2, and EC3) are analyzed by combusting the remaining material off the quartz filter at successively higher temperatures, again measuring the resulting carbon as converted to methane (Figure 1, red region).

Figure 1. A “thermogram” for TOA analysis of an example CSN filter with a successful laser correction.

During the heating in the no-oxygen phase, some of the deposit becomes pyrolyzed, or charred, and will not evolve until burned in the oxygen phase. To account for this method-generated EC, a correction based on the laser measurements is applied. A laser measures the initial reflectance and transmittance of the sample (Figure 1, top panel). During the no-oxygen phase, as the sample chars, the laser signal (both reflectance and the transmittance) will decrease as the sample gets darker. Then, once oxygen is added, the EC begins to combust and the sample gets lighter. Until the laser signal reaches its initial level, it is assumed that the EC was created during the no-oxygen phase. This is the OP fraction (Figure 1, middle panel, green region); the carbon

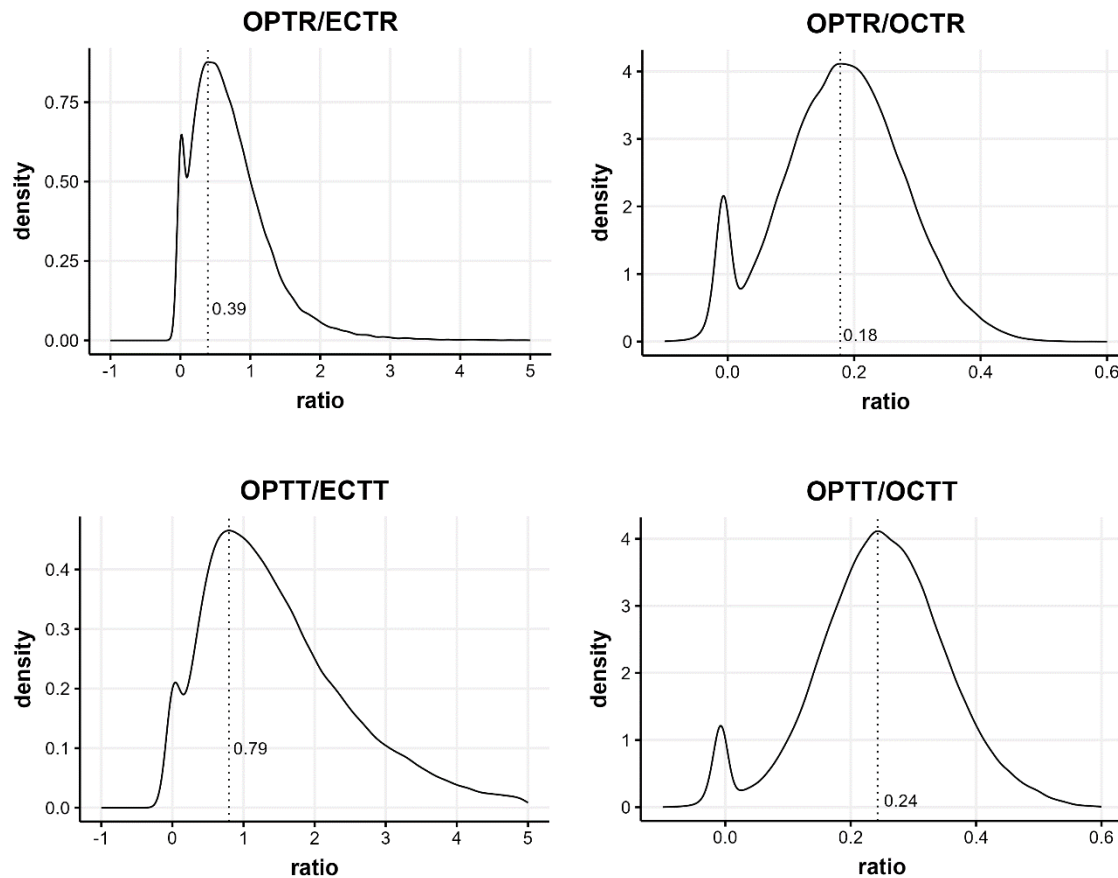
The impact of no laser correction depends on the magnitude of the correction relative to the magnitude of total OC and EC. This varies by sample, and density plots of the ratio of the OP correction to the total EC or OC are shown in Figure 3. The OP correction is generally larger for transmittance than reflectance, but there is a wide distribution. For example, $OPTT/ECTT$ is typically between 0 and 4. That means that the OP value can be up to four times larger than the total EC value. Thus, if this correction cannot be applied, the total EC may be overestimated by 400%, and is most commonly to be overestimated by 80%. Conversely, because OP is added to OC, total OC values will be underestimated when OP is zero, but the relative impact is smaller, between 0 and 60%, with the most common correction around 20%.

Figure 3. Density plots of the ratio of OP over EC (left) or OC (right) by reflectance (top) and transmittance (bottom). Dotted line indicates the mode.

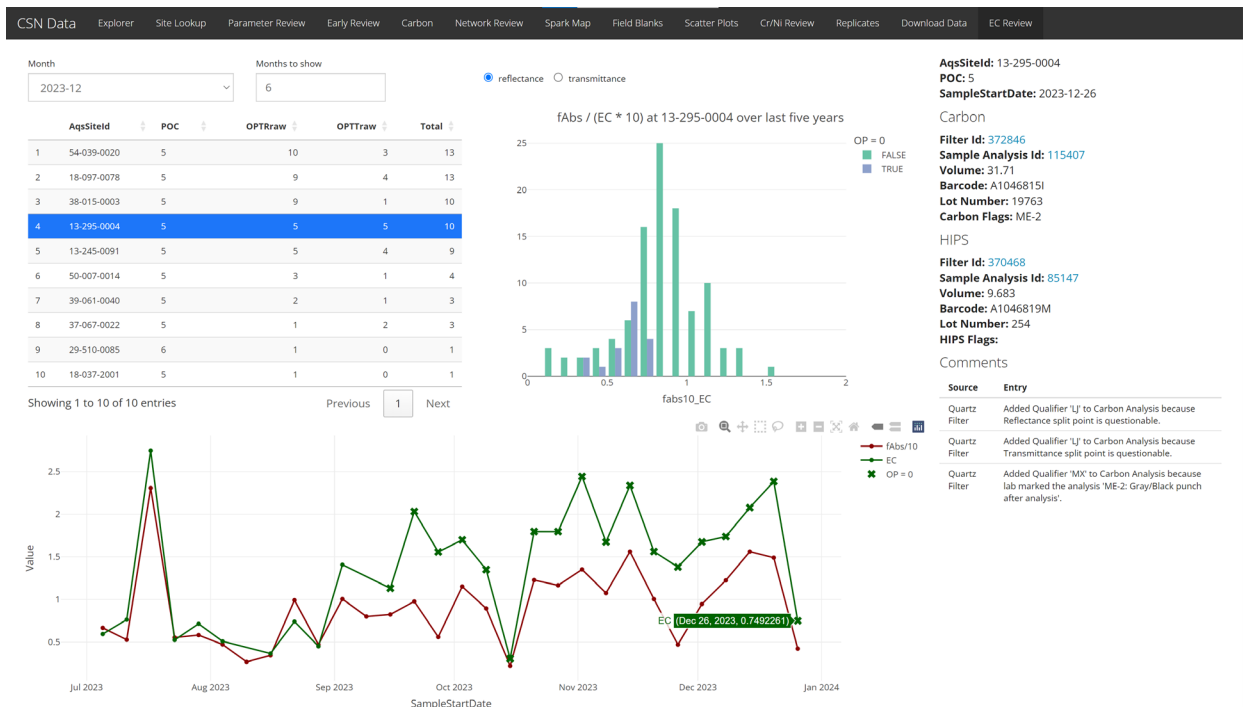
UCD has developed validation procedures for identifying cases where the TOA laser signal cannot be resolved and applying the appropriate flags.

- 1) A null code is automatically applied to OPTT and ECTT if $OPTT = 0$. A qualifier code ('LJ') is applied to OCTT.
- 2) A null code is automatically applied to OPTR and ECTR if $OPTR = 0$. A qualifier code ('LJ') is applied to OCTR.
- 3) The Fabs/EC relationship is reviewed for sites flagged in steps 1 or 2 using validation tools such as the screen shown in Figure 7. If the Fabs/EC ratio is consistently low over multiple sampling days at the site relative to historical values, sampler contamination is suspected and the 'SC' null code is applied. If Fabs is also elevated, or other evidence for high concentrations of absorbing particles is observed (e.g., visible wildfire smoke plumes), then sampler contamination is not suspected and the 'BH' null code is applied.

Figure 7. Screenshot of the EC review tool UC Davis validators use to determine appropriate null codes for unresolved TOA laser corrections.
