STATEMENT OF BASIS

MAX ENVIRONMENTAL TECHNOLOGIES, INC.
YUKON FACILITY
233 MAX LANE
YUKON, PENNSYLVANIA

EPA ID NO. PAD 004 835 146

Prepared by
RCRA Corrective Action Program
Land, Chemicals and Redevelopment Division
August 2020

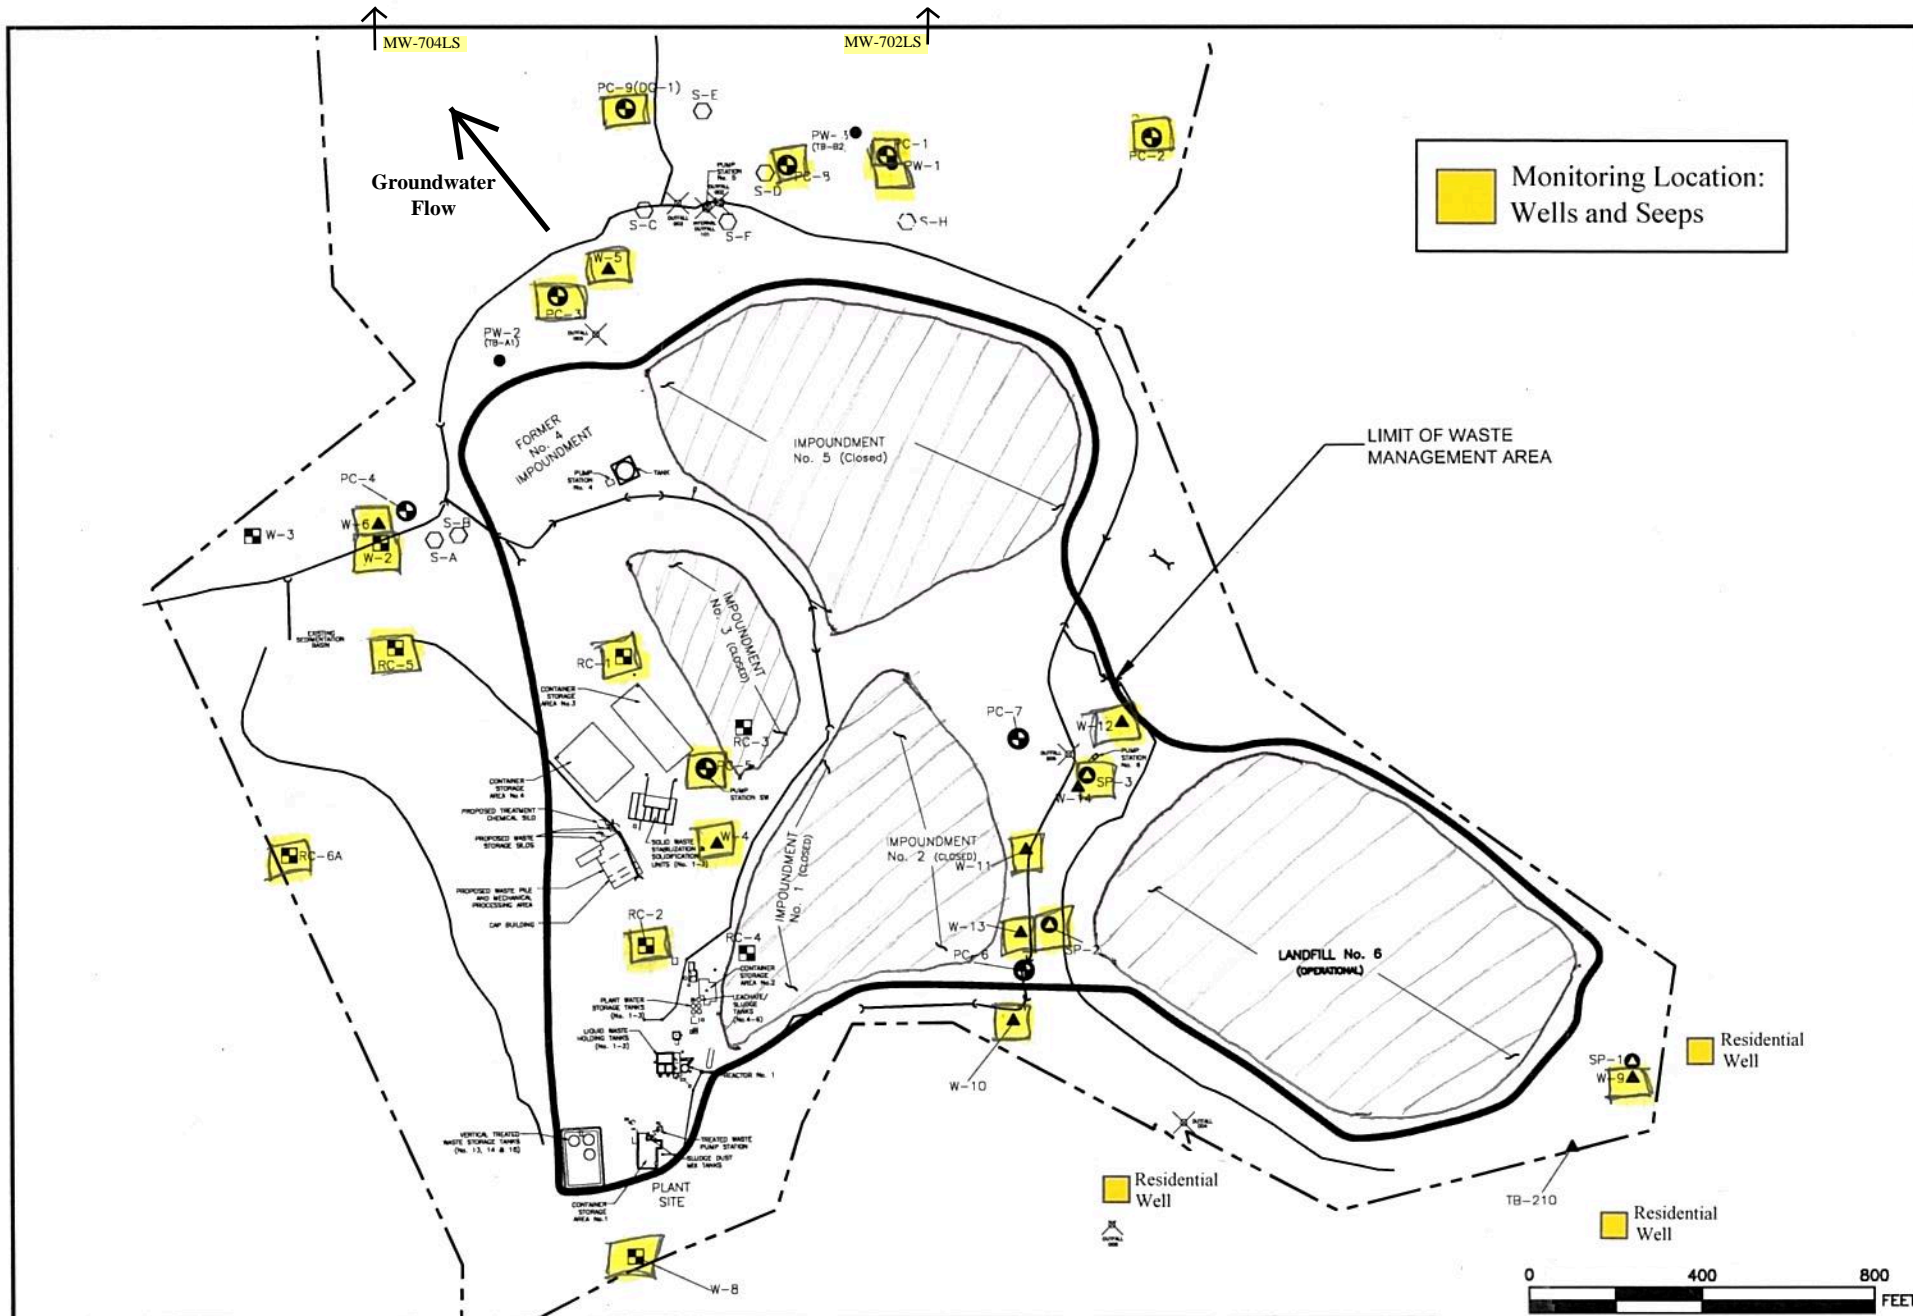
FIGURE 2

Waste management units at the Facility include five closed impoundments, an active landfill, waste storage tanks and containers, waste treatment tanks, and a leachate management-wastewater treatment system. The waste management units and monitoring locations are depicted on Figure 2, Facility Layout, and are further described as follows.

Facility Layout

Currently, the Facility Wide Monitoring Program incorporates the closed impoundments and Disposal Area 6. The monitoring locations are identified in Figure 2, Facility Layout.
